## SUPPLEMENTAL DATA

### Investigation and Hearing

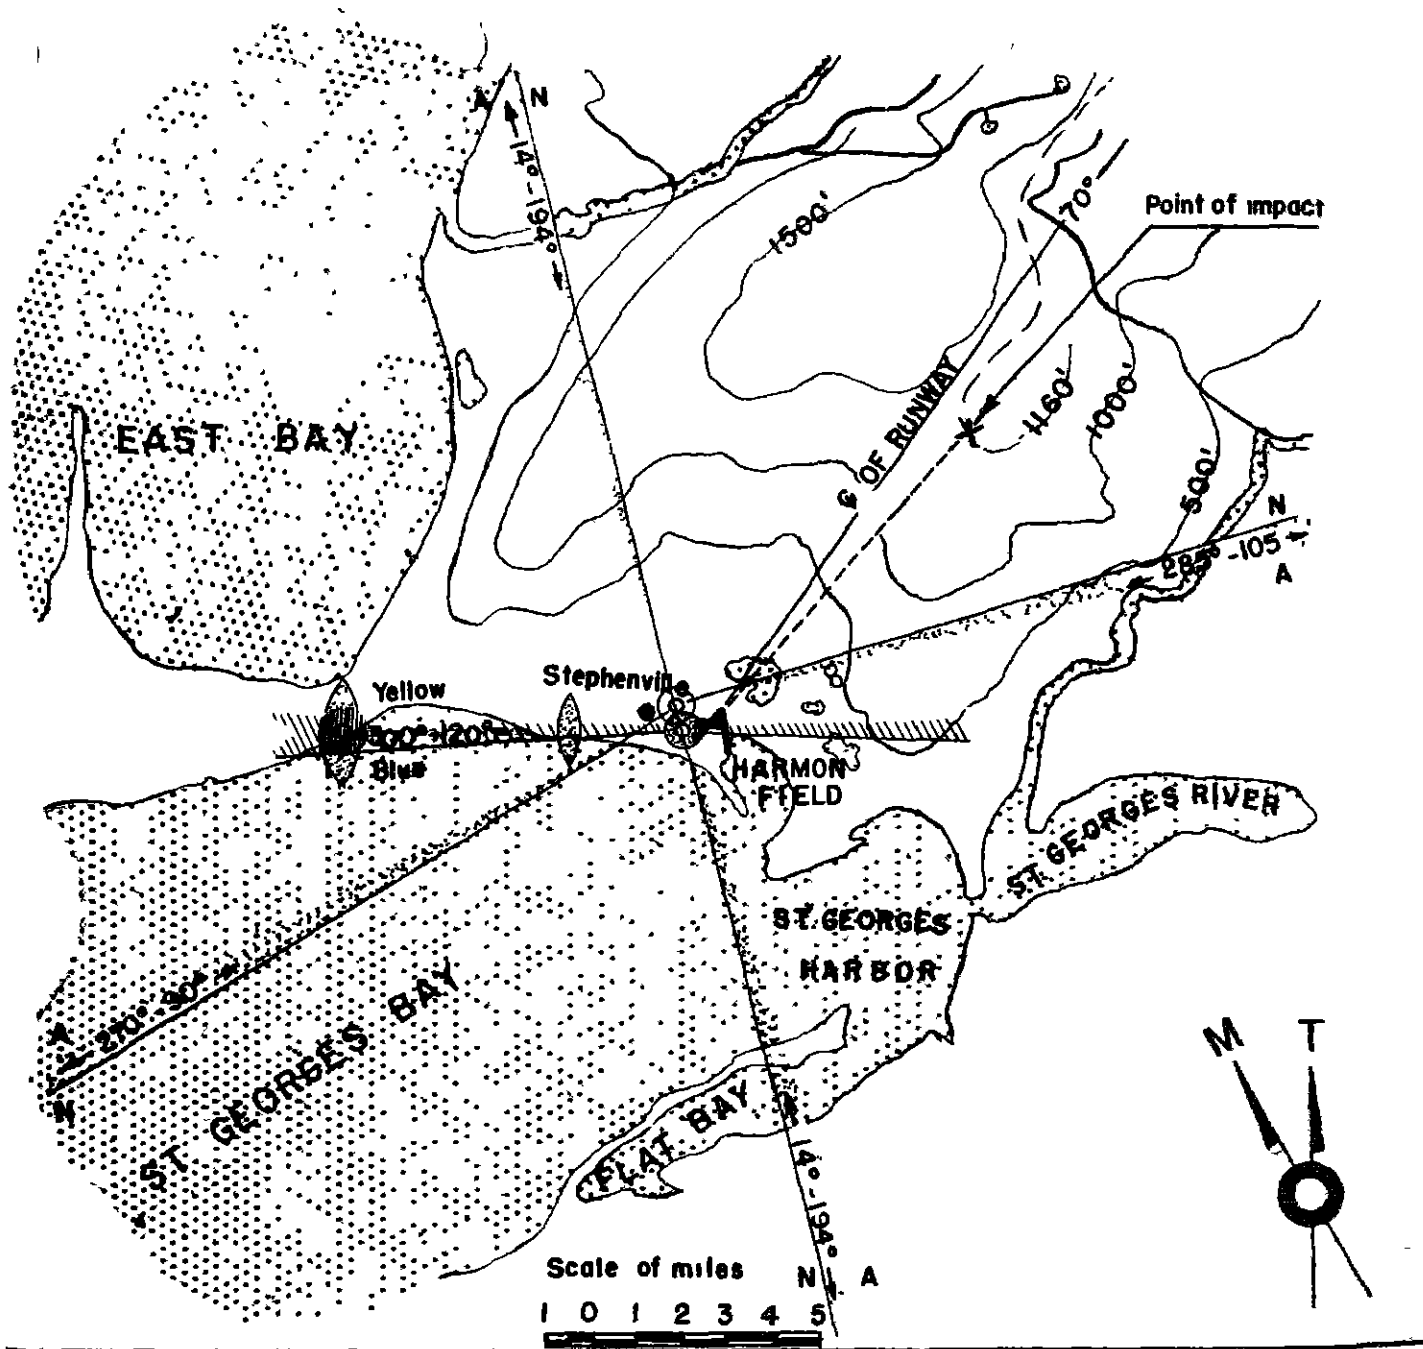
CHART OF THE STEPHENVILLE AREA

The above chart shows the approximate flight path of Aircraft 904 after take-off from Harmon Field, and the point of impact. The contours clearly illustrate that a turn may have been safely made following take-off from Runway 7 and that a climb could have been accomplished away from the high terrain north of the field.

The aircraft had crashed against a steep ridge at a point 7.1 miles from the take-off end of Runway 7 at a magnetic bearing of 76 degrees 45 minutes from the center of the airport and at an elevation of 1,160 feet.\* The elevation of Harmon Field is 22 feet. An inspection of contour charts of this area indicates that the terrain northeast of Harmon Field rises to an elevation in excess of 1,500 feet through an azimuth extending from approximately 20 degrees magnetic to 90 degrees magnetic. Directly in line with Runway 7 and approximately 7-1/2 miles from the airport lies a depression the lowest elevation of which is slightly under 1,000 feet. The terrain toward the southeast is relatively flat. The field is bounded by St. George Bay toward the south. Toward the northwest several hills rise to an elevation between 1,000 and 2,000 feet.
