ACCIDENT NUMBER

45-2-10-5020

DESCRIPTION OF ACCIDENT

AIRCRAFT ACCIDENT
GEORGE P. BRADLEY 1ST LIEUT
P-47MIG 44-21178
61ST FIGHTER SQUADRON
10 FEBRUARY 1945

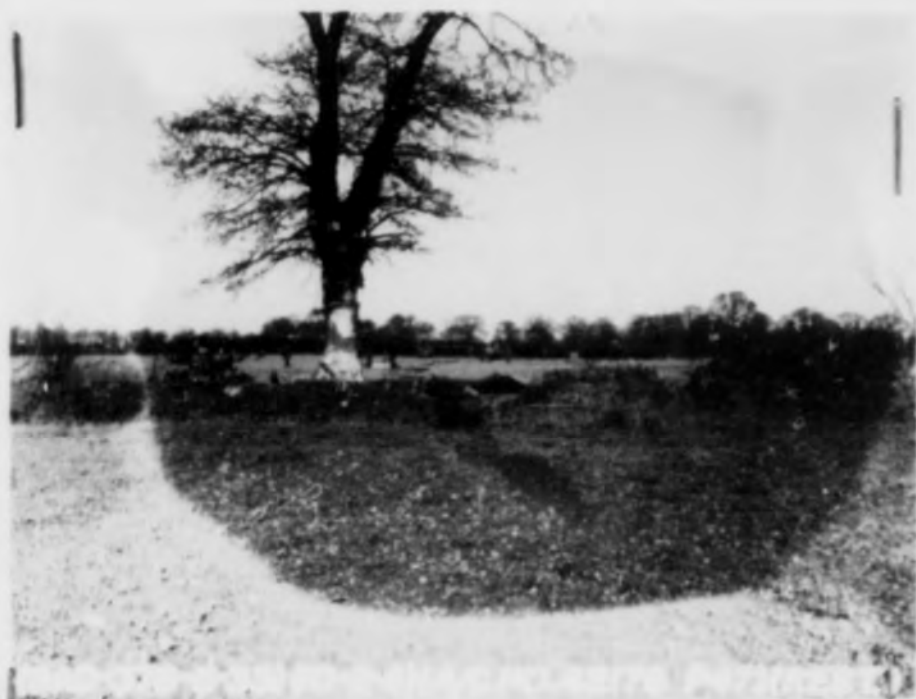
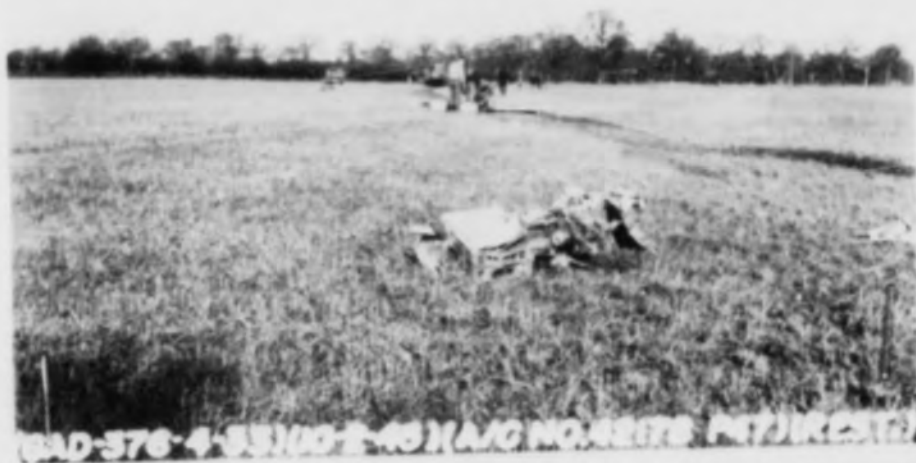
After a power check at 20,000 feet, Lt. Bradley reduced his settings and started an easy let down, using about 35" manifold pressure. Upon reaching the field, he crossed the edge of the field, preparatory to entering the traffic pattern. He then noticed he had lost power and went thru a cockpit check in an effort to find the trouble. When Lt. Bradley decided he couldn't regain power he was at 400 feet and too far from the field to land there. He made a crash landing in a small field. On his approach he hit a tree and lost his left wing. The pilot was unhurt, but the ship was damaged beyond repair.

Depot investigation and test of the carburetor revealed a malfunction of the automatic mixture control which produced an extremely lean mixture at low altitude after high power settings had been employed at high altitude.

The Committee attributes this accident to 100% materiel failure of the carburetor.
