DIXIE BELLE

ACCIDENT No. 120
 45-8-9-536

REPORT OF AIRCRAFT ACCIDENT

(1) Place AAF STATION 123 - APO 558 (2) Date 9 August 1944 (3) Time 0951
 AIRCRAFT: (4) Type and model B-24 H 270 (5) A. F. No. 42-95163 (6) Station AAF 123 - APO 558
 Organization: (7) 8th (8) 458th (9) 751th
 (Command and Air Force) (Group) (Squadron)

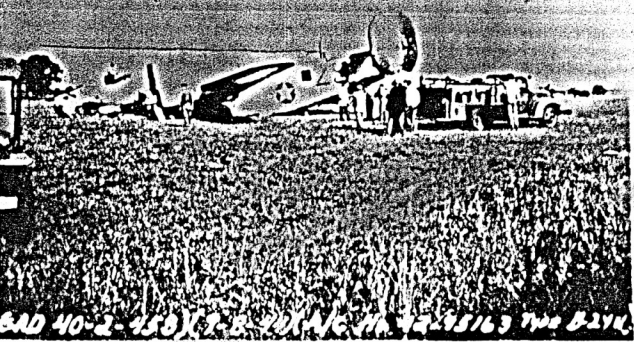
SAD 40-2-458 (T-B-42) AK No 42 95163 Type B-24

The pilot Lieutenant HESS, was not able to get properly aligned with R/W 23, tried to go around, but he could not gain airspeed. The A/C crash landed in the middle of the airfield. No one was hurt but the A/C was completely destroyed.
