ACCIDENT NO. 1409

WAR DEPARTMENT
U. S. ARMY AIR FORCES
REPORT OF AIRCRAFT ACCIDENT

SUBJECT: Report of Inspection.

SUBJECT: Report on A/C B 24 H. 42-7516.

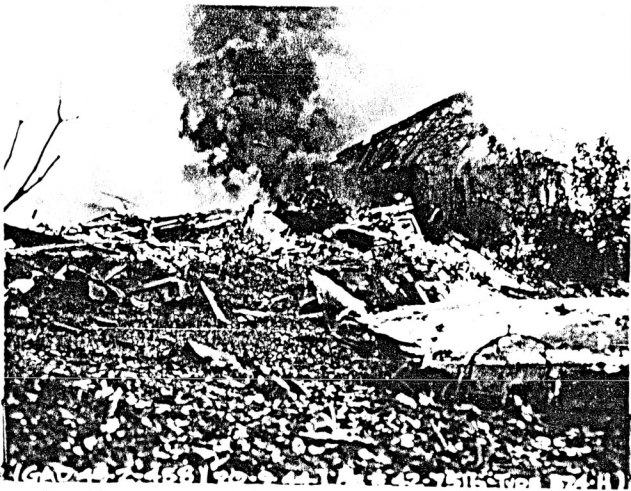
(GAD-44-2-458) 20-9-44-1-4-42-7-516-708 174-H

An inspection of the wreck showed the wing flaps in the fully retracted position (see pictures), but no eye-witness was able to state positively whether this was the case at take-off or not.

f. Upon inspection of the crashed aircraft a part of the right wing was found at the point of impact. A part of the left wing was found on across the street. This part of the left wing housed the flap cylinder which was in the fully retracted position. The flaps on both sections of the wings examined were fully retracted in the up position. Another small section of the left wing was found about twenty (20) feet away and this part had a small section of the flap resting in the retracted position (Pictures have been made of these observations).
