B-24H

ACCIDENT No. 45-3-9-328

REPORT OF AIRCRAFT ACCIDENT

(1) Place AAF Station 123 R/W 05 (2) Date 9 Mar 45 (3) Time 0859
 AIRCRAFT: (4) Type and model B-24 H 10 (5) A. F. No. 41-28697WV (6) Station: AAF 123
 Organization: (7) VIII (8) 458th Bomb Gp (9) 754th Bombardment Squadron (H)
 (Command and Air Force) (Group) (Squadron)

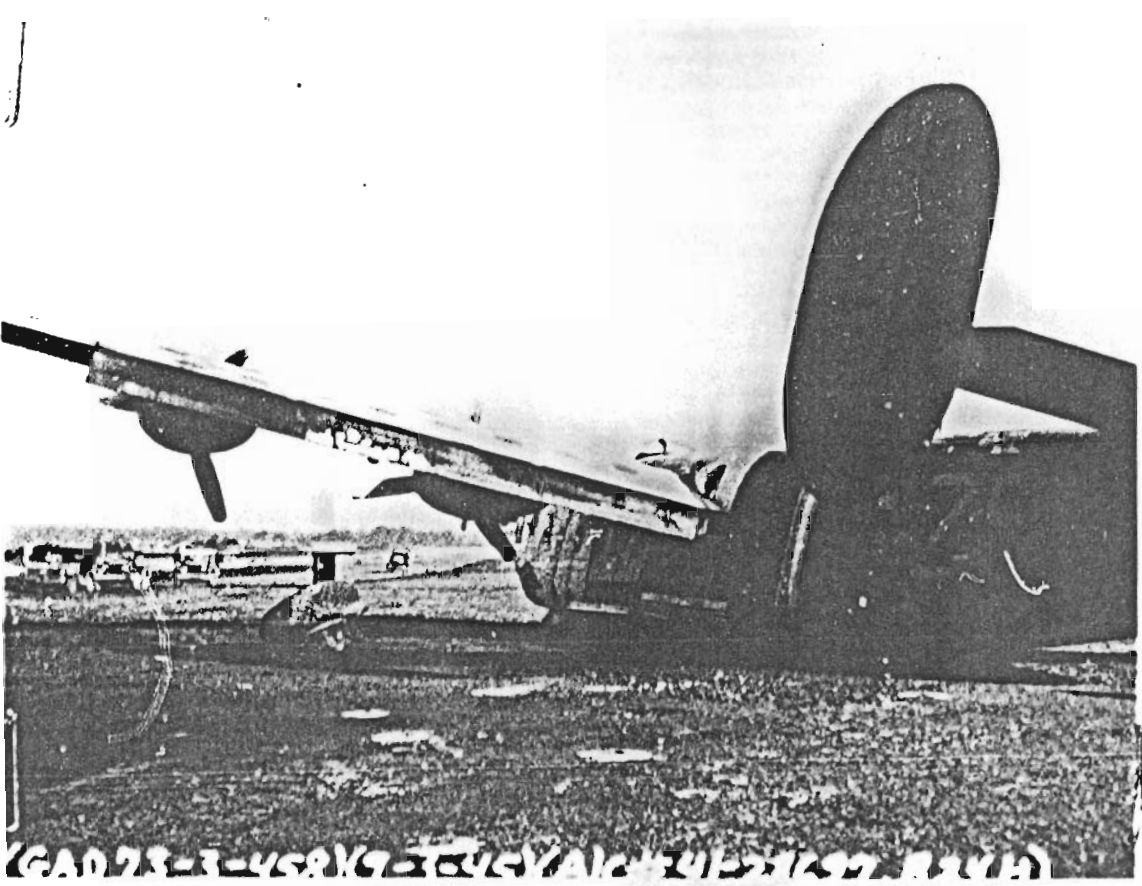
(GAD 73-3-45819-345/AIC#41-21197 B24H)

On 9 March 1945 at 0900 hours B-24 H, 41-28697~~WW~~ returned to Station 123 from routine weather flight in Assembly area. Light cross wind was encountered on landing but Pilot states he had no trouble and touched down well within the first third of R/W. Right brake pedal broke when brakes were first applied causing plane to turn off R/W to the left. There seemed to be some confusion in the cockpit as to what had happened, the Pilot was unable to get the Co-Pilot on the controls until the plane was well off the R/W. Right brake was locked, about 110 feet before the left but due to the wet grass the brakes gave no directional control and the plane skidded side ways about 350 feet before hitting a hardstanding at which point the landing gear was sheared off and the plane was damaged beyond economical repair.

- The linkage between the ball crank and the lever arm on the pilots right brake peddle broke when pressure was applied while the airplane was landing. The airplane swerved to the left and went off of the runway on to rough ground which caused the landing gear to collapse. Airplane has been classed as salvage.
- probable cause; The cause of this failure was probably defective material in the broken linkage.
- recommendations; None
- Disposition; Subject airplane has been turned over to the 469th Sub-Depot for salvage.
