**REPORT OF AIRCRAFT ACCIDENT**

129 1788  
45-9-30-512

(1) Place AAF Station 376 (2) Date 30 September 1944 (3) Time 1836  
 AIRCRAFT: (4) Type and model B 24 (5) A. F. No. 41-29452 (6) Station AAF 123  
 Organization: (7) VIII (8) 458th (H) (9) 754th (H) (Squadron) 2180  
 (Command and Air Force) (Group)

(56) Nature of accident Landing accident.

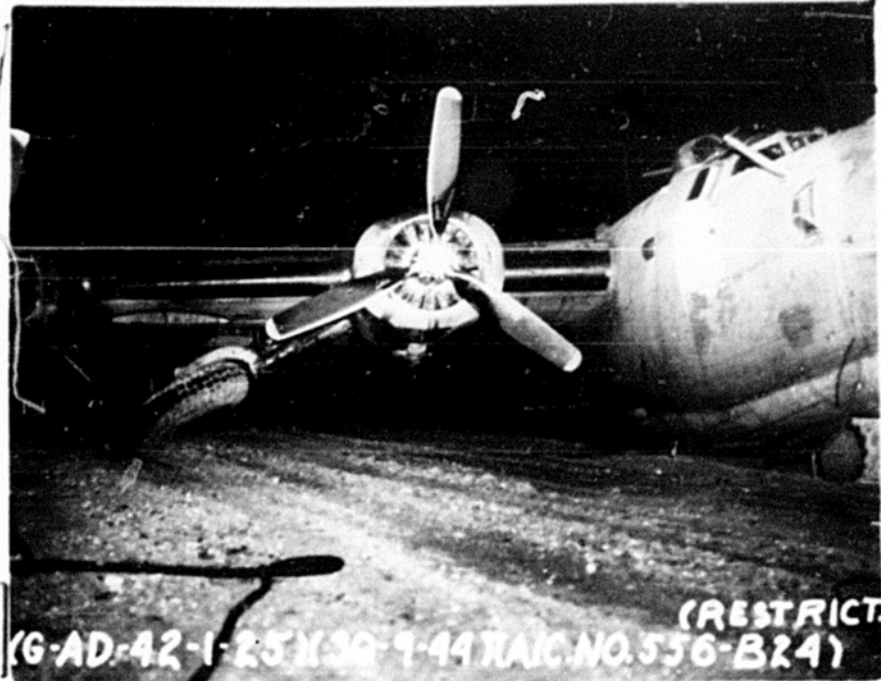
(G-AD-42-1-25)(30-9-44)(AIC NO. 556-B24) (RESTRICTED)

AT 1836 hours 30 September 1944 B 24 H, 41-29452, piloted by Lieutenant SWARTZ of AAF Station 123 crashed landed at AAF Station 376. The right landing gear was broken at the support elbow, possibly caused from the extremely rough perimeter tracks and R/W at Lille, France, from whence it had just returned from a trucking mission. Upon impact on R/W 29, AAF Station 376 the right main gear collapsed causing damage to under fuselage and No 4 prop.

While taxiing to takeoff from Vendeville it was noted that the gear sounded as though it were binding and that the oleo action was slow. On arrival at this station the gear was put down in a normal manner and the engineer went back to the waist to check the gear down and locked. He discovered that the drag strut on the right main gear had broken off at the elbow. Probable cause of this breakage was taxiing over rough terrain at Vendeville airport and takeoff from a rough runway.
